# First Glance Home Inspections LLC

## Property Inspection Report

Inspector: James Emenaker

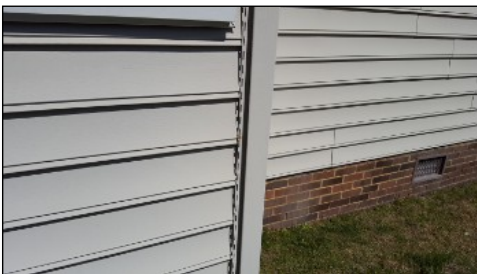
2.1. Some minor siding damage was noted. Have repaired as necessary to prevent further deterioration.

trim not secured

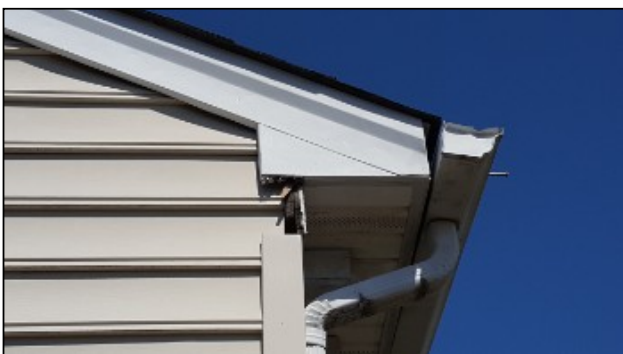
3.2. A piece of the fascia board on the left side of the home was missing. This piece will need to be replaced.

fascia board missing

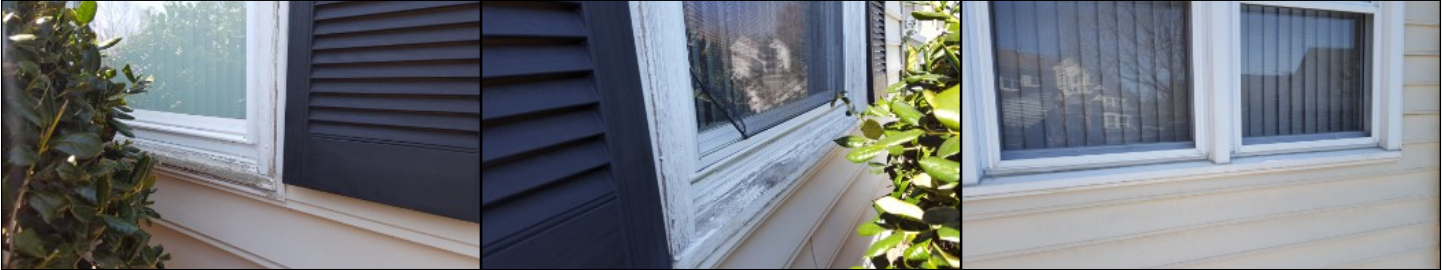
5.1. Some window screens are damaged and may need to be replaced.

5.2. Peeling paint observed, suggest scraping and painting as necessary.

trim board needs painting

screen broken

damage to rear screens

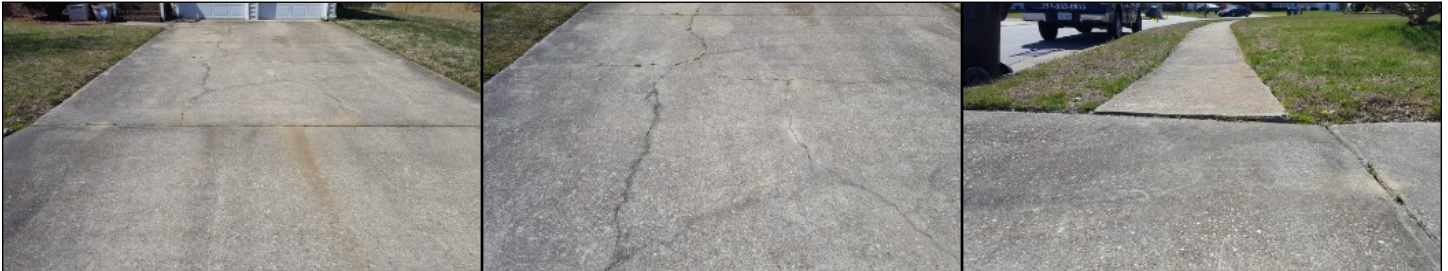
1.1. Driveway in good shape for age and wear. No major deficiencies noted. There was some typical cracking.

1.2. Please note that there is a trip hazard where the driveway meets the public walk. This may or may not be the home owners responsibility.

typical cracking

trip hazard on public walk

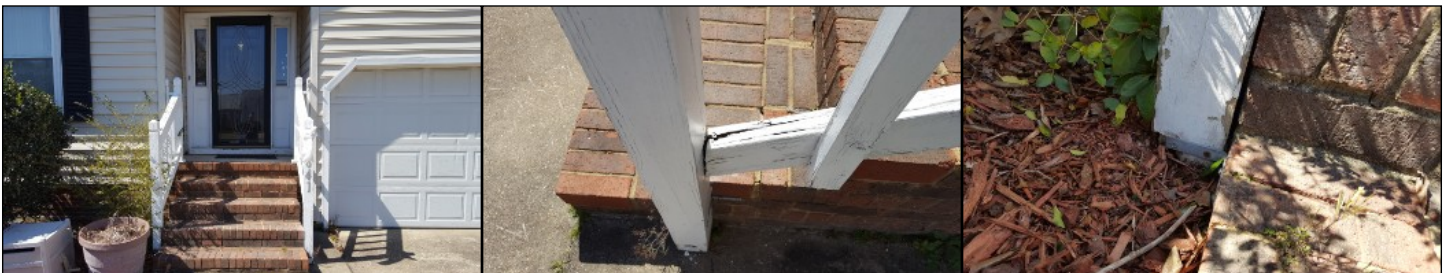
2.1. The handrails for the front porch are in need of some repair. The rail on the right side has cracked all the way through and will need to be replaced. The post on the left side is soft due to sitting in the moist soil.

cracked rail

soft wood

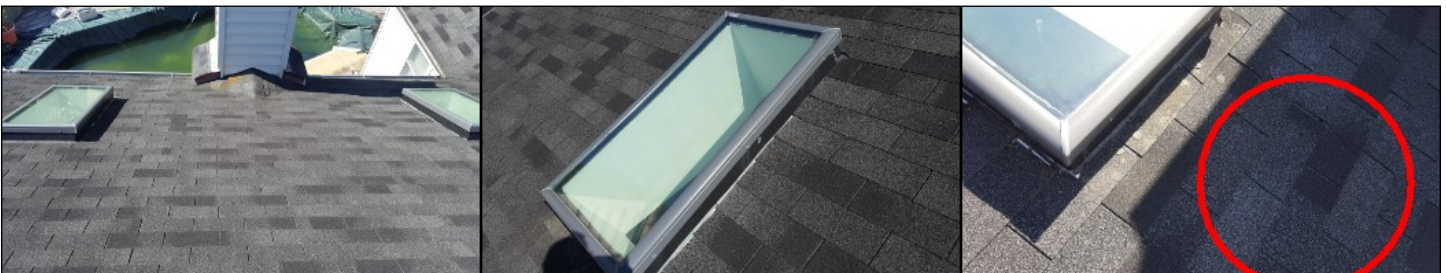
2.2. There was a soft spot under the skylight closest to the sliding door. Inside there were some water marks noted on the wood trim.

soft sheathing below skylight

exposed nails

2.1. All exposed nails need to be caulked to prevent any water intrusion.

caulk all exposed nails

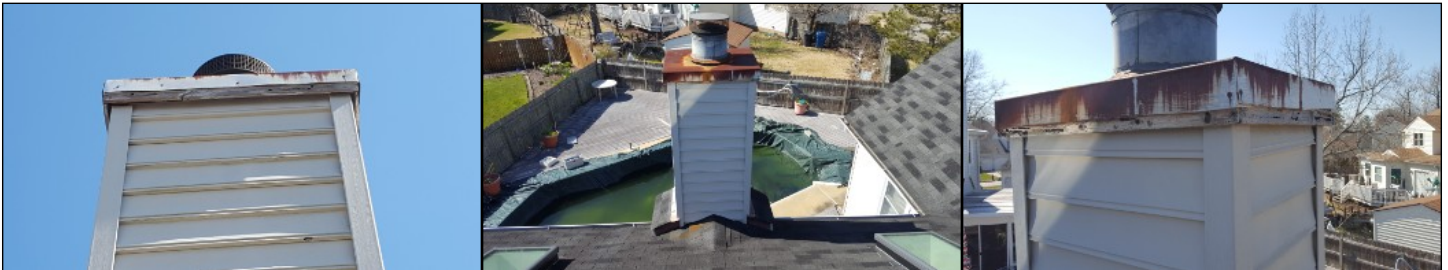
5.1. The wood trim at the top of the chimney had several holes and tunnels bored through it. This appears to be due to carpenter bees.

possible insect damage

possible carpenter bees

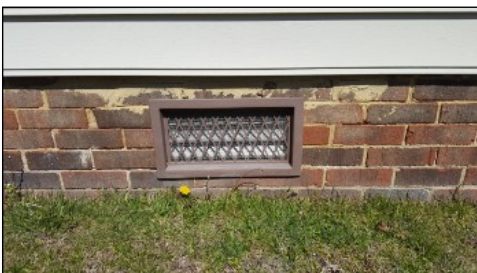
some mortar work has been  
done

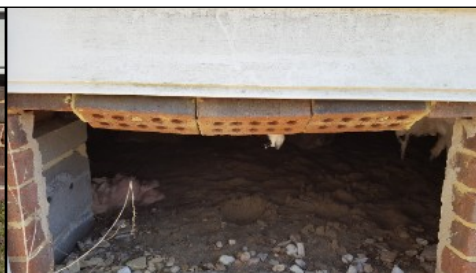
2.1. The access for the foundation had been removed and has caused the few bricks in that area to sag. This should be corrected.

missing lentle

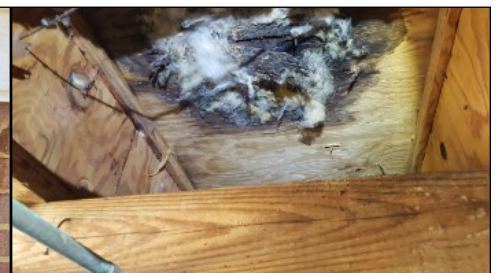
2.3. There was sheathing deterioration on the subfloor under the master bath and under the fireplace. These areas were at normal moisture levels at the time of inspection.

deteriorated sheathing

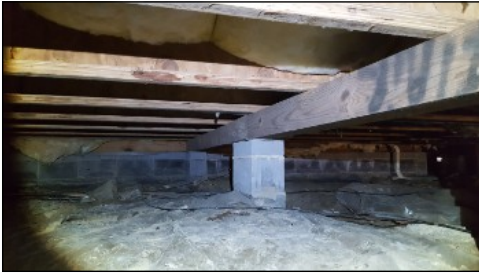
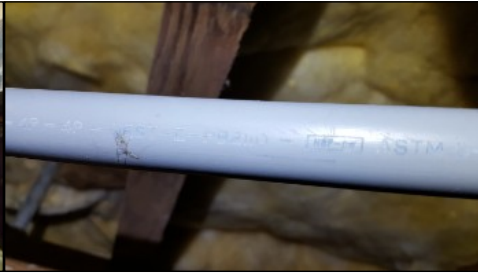
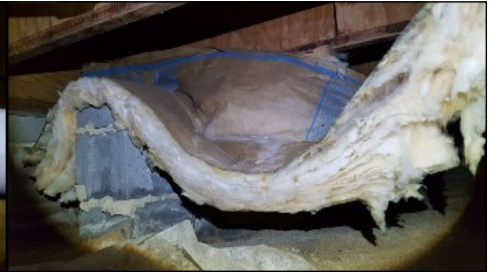
2.2. Some of the insulation has fallen in the crawlspace. If the insulation has fallen due to saturation it either needs to be replaced or thrown out.

2.4. The water supply piping appears to be PB pipe. PB pipe is not used anymore due to issues with the integrity of some of the piping. More information can be found here <http://www.polybutylene.com/poly.html>

pb pipe

fallen insulation

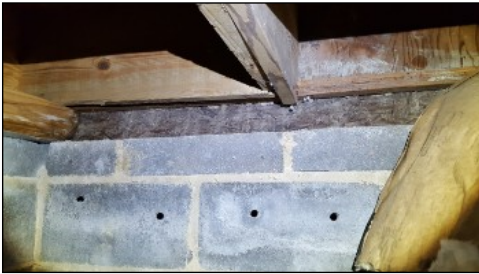
20% moisture

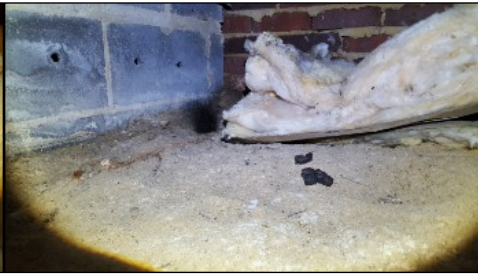
some sort of critter

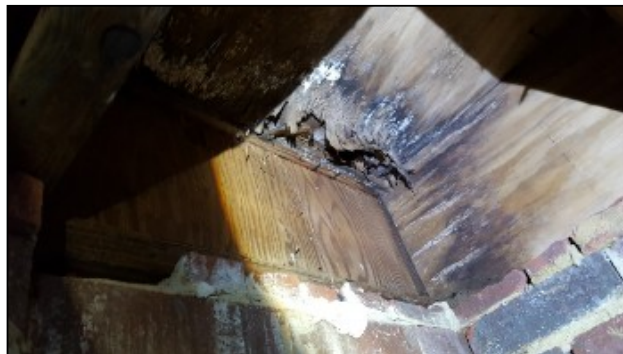
deterioration under fireplace

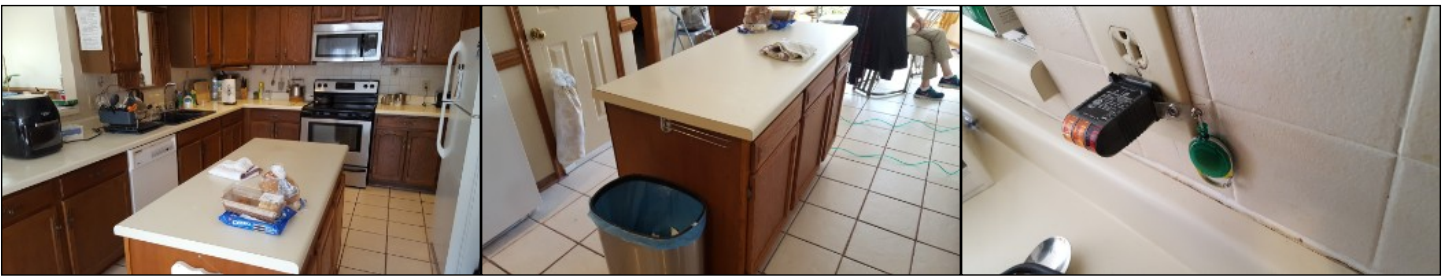
1.2. The counter close to the fridge was not well secured to the bottom cabinet.

1.3. **SAFETY CONCERN:** The outlet near the kitchen sink is not **GFCI** protected. Recommend adding one for safety.

No gfcı

hot water side stripped

light removed

counter top is loose

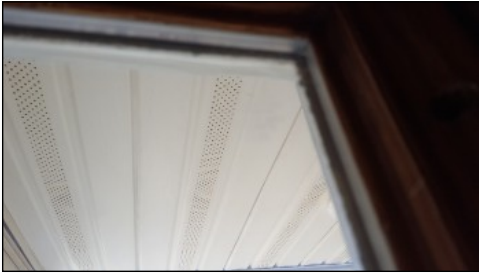
tempered glass

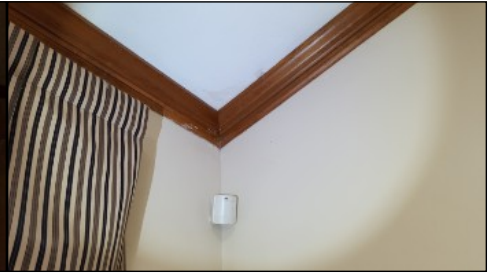
2.2. There were some stains present on the ceiling under the skylight. These leaks may have been from an old skylight before the new roof was installed.

water stain

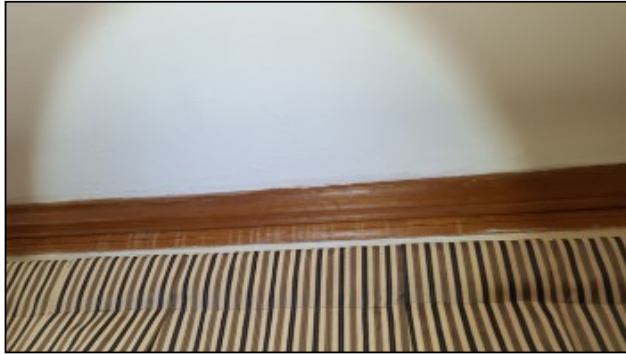
water stain

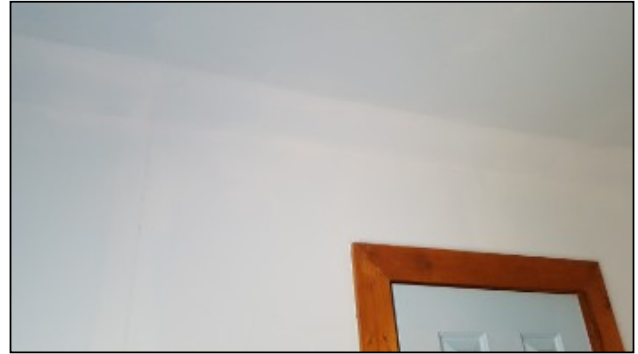
2.3. The frog had numerous cracks at the drywall seams. This may have due to installation practices in this room.

cracking at the seams

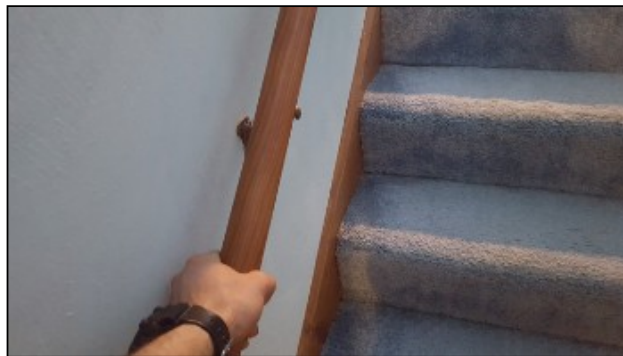
3.1. The handrail is loose and should be resecured to the wall.

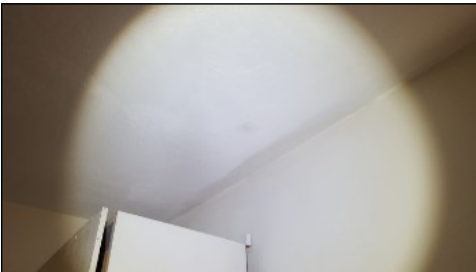
2.1. MONITOR: There are some water stains noted in the ceiling of two of the bedrooms. These did not appear to be active leaks. Monitor that these areas don't become worse.

Water stains

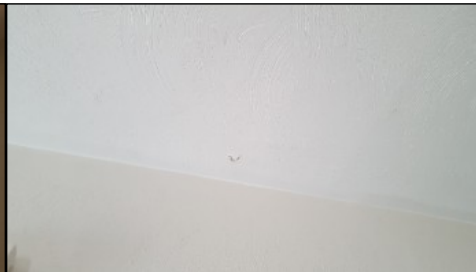
nail pop

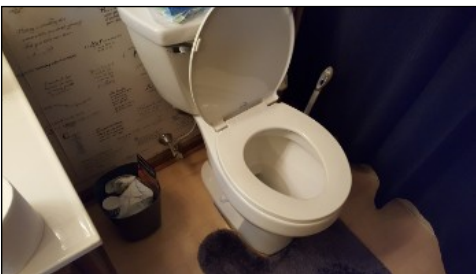
2.1. The two toilets are slightly rocking. This condition can cause the wax seal to fail and leak. No signs were noted in the crawlspace at this time.

toilet slightly rocking

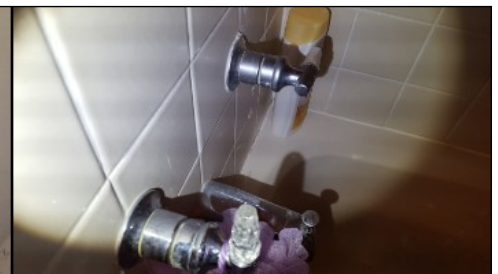
2.3. Water is leaking through the cold water valve when the hot water side was turned on. The stems may need to be replaced.

leaking through cold water stem

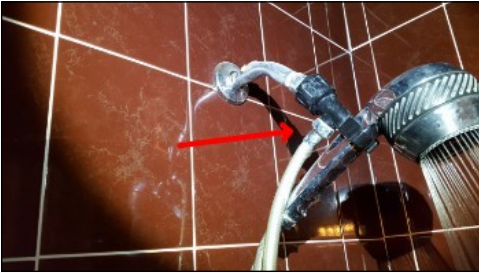
2.5. There is a small leak at one of the connections for the master bath shower head.

leaking

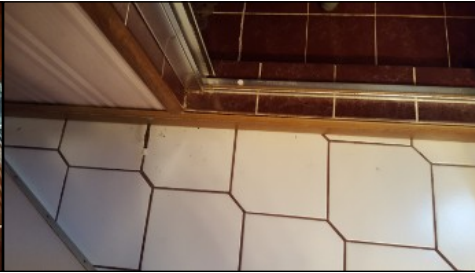
trim is loose

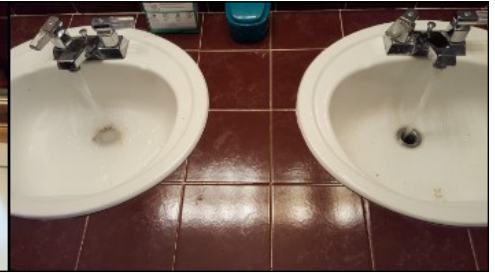
pitting in the sinks

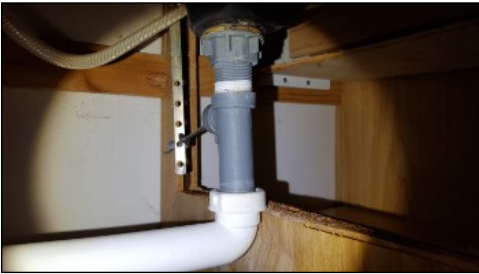
2.6. There is a slow leak in the right drain of the master bath. This has caused some deterioration to the bathroom vanity.

slow leak

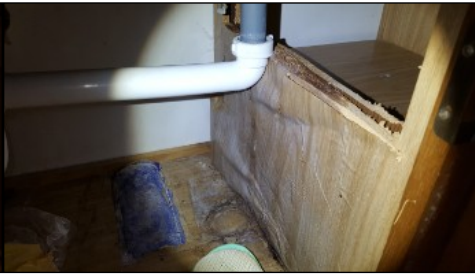
Deteriorarion

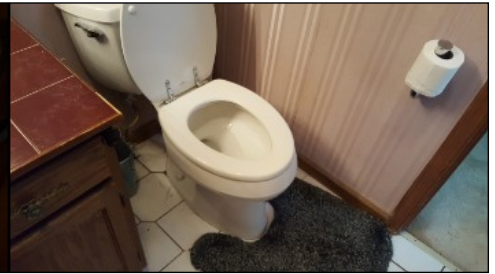
toilet slightly rocking

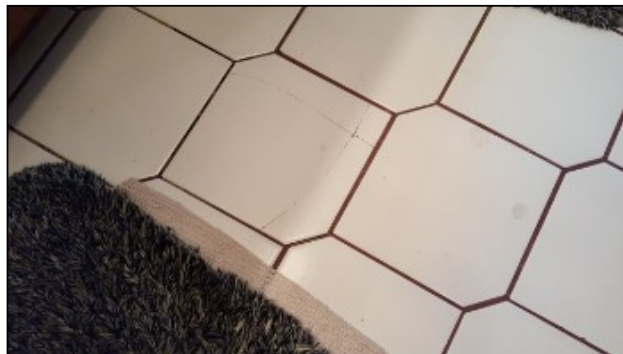
Cracks in the tile

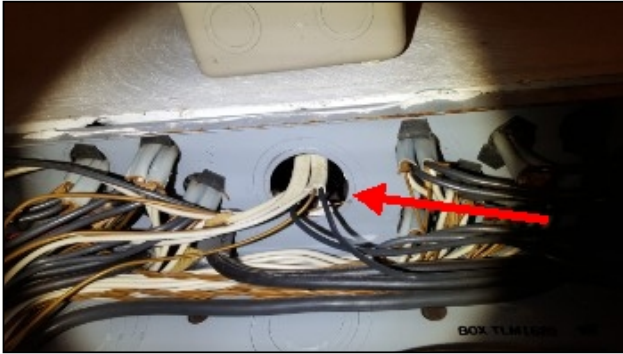
Missing bushing at the knockout to protect wiring.  
Neutral wires should always terminate on individual lugs of the busbar. Grounds can share a lug.

missing bushing

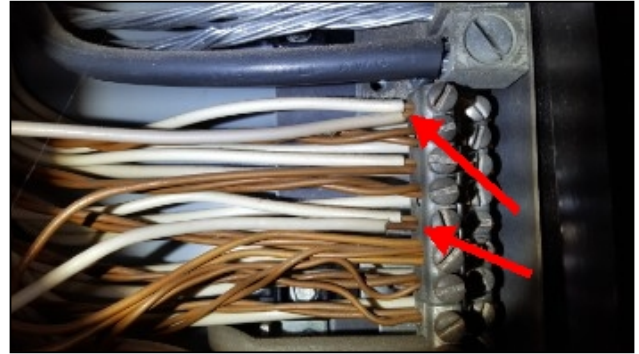
neutrals should be on individual lugs

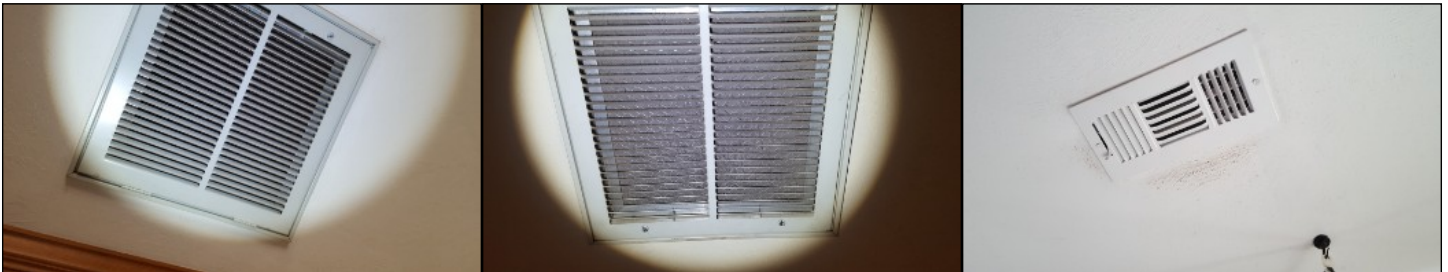
1.2. Most of the filters in the home were dirty and needed to be replaced.

dirty filters

system may need a cleaning

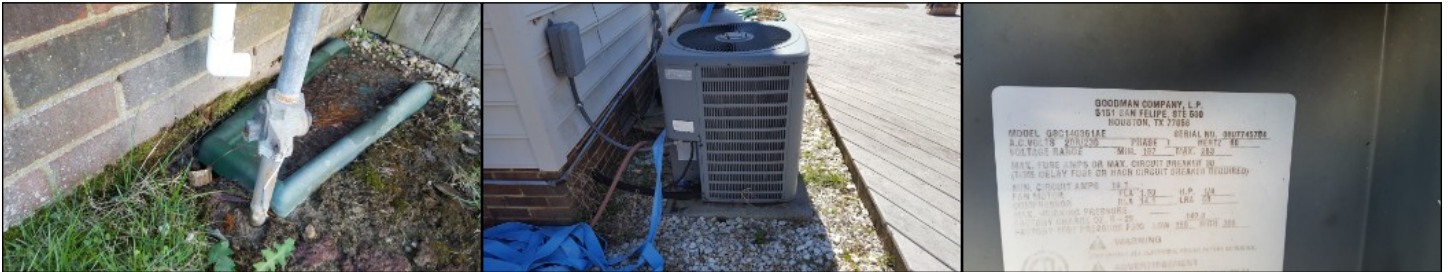
2.2. The condensation lines should be diverted away from the foundation.

should divert away

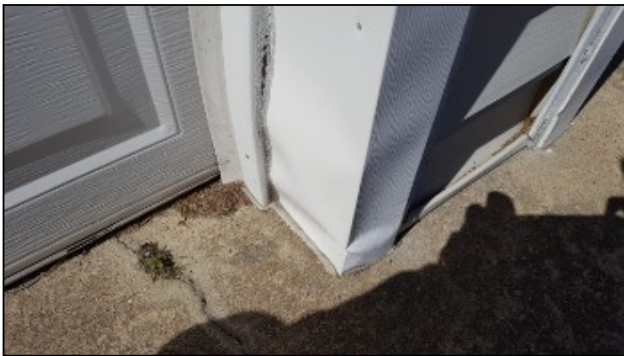
2.1. Some of the trim around the garage door is buckling. I recommend that this trim be cut to leave a half inch gap from the concrete. The gap can then be caulked. This can prevent any wood behind the trim from wicking up moisture.

trim buckling

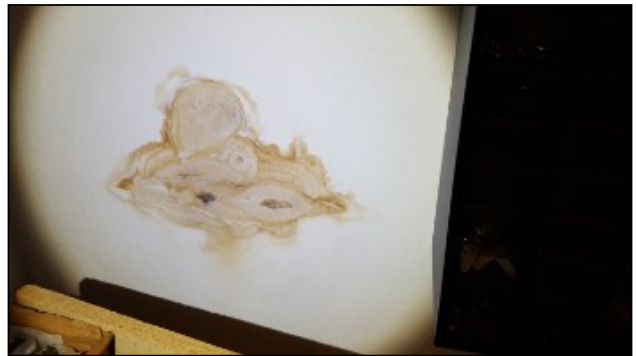
2.2. There was some moisture and bio-growth found on the back wall of the garage. Though no leaks were noticed this may be coming from behind the hot water heater. The wall may need to be exposed in order to properly evaluate and repair the area.

moisture and bi-growth

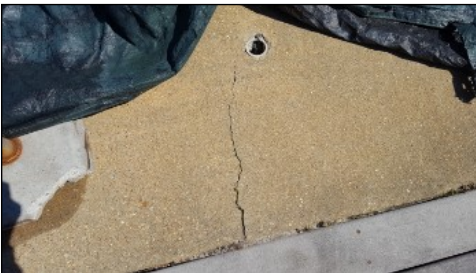
1.1. There was a crack at the ladder anchor and the diving board anchor. This is pretty common as these areas are often stressed.

crack at ladder anchor

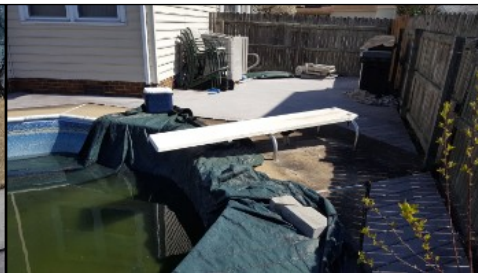
1.3. Please note that some insurance companies will not offer a policy until a diving board is removed due to liability reasons. Please check with your insurance company.

Diving board

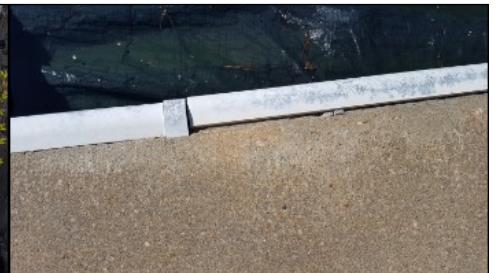
1.2. The coping was pulling away in one of the areas closest to the home. This section still felt solid.

coping loose

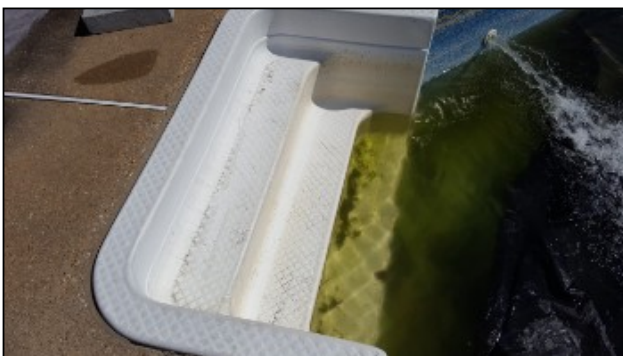
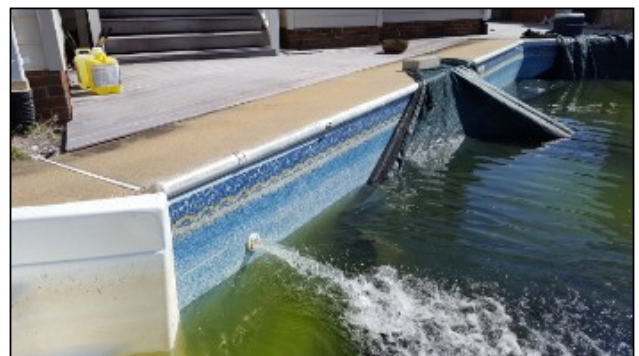
2.3. The water level in the pool was low and the skimmer had to be closed in order for the pool to run. The seller disclosed that the water drains to this level every year. Recommend a qualified pool technician evaluate and make repairs as needed. Please note that this type of work may need to go to a leak detection company.

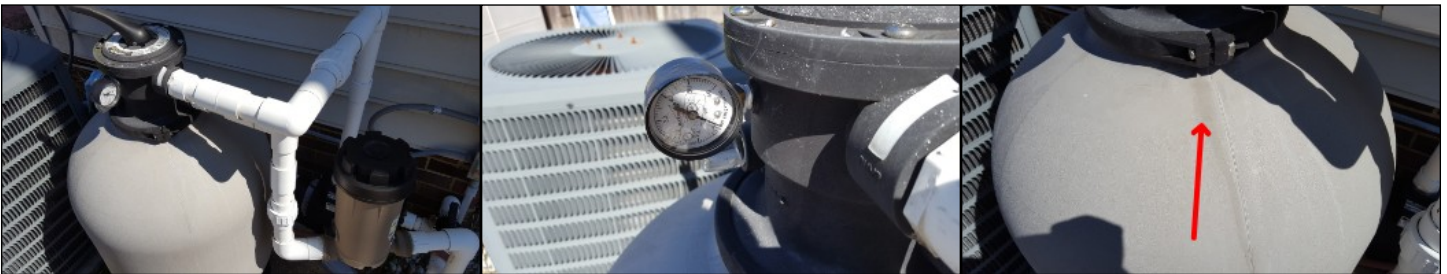
4.2. The filter gauge is broken and will need to be replaced.

4.3. There were two leaks noticed as the pool was running. The o-ring at the bottom of the 6-way valve was leaking. The 6 way valve gasket is also damaged. When the system was in recirculate the water was coming out of the waste port. Recommend having a pool technician make repairs as necessary.

Broken gauge

possible leak at 6 way valve

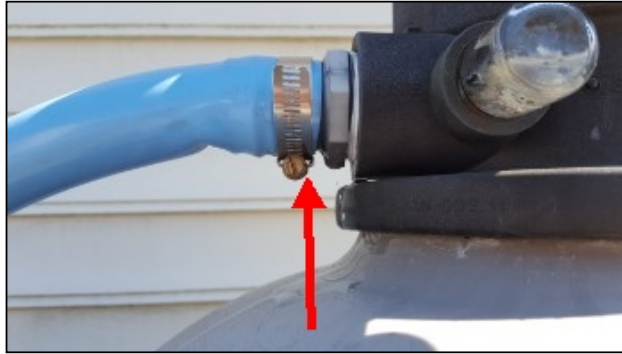
6 way gasket leaking

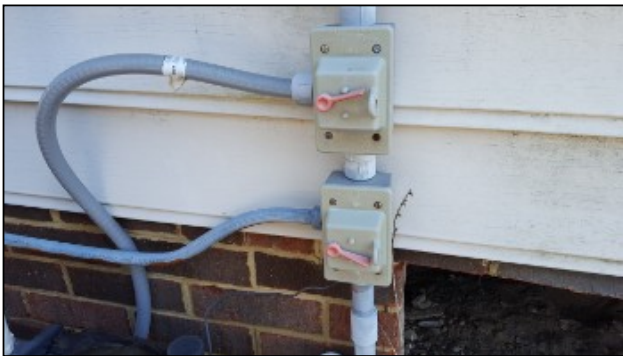
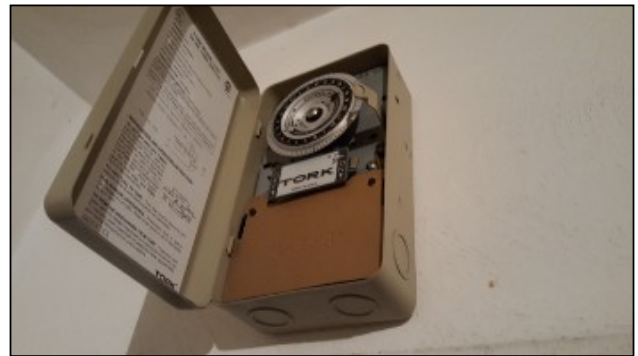
7.1. There is a timer installed for the pool pump. Please note that the timer was making noise even when it was in the off position. The timer may need to be repaired or replaced.

timer is noisy
