# First Glance Home Inspections LLC

## Property Inspection Report

Inspector: James Emenaker

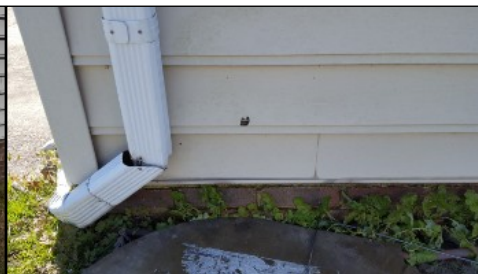
small hole

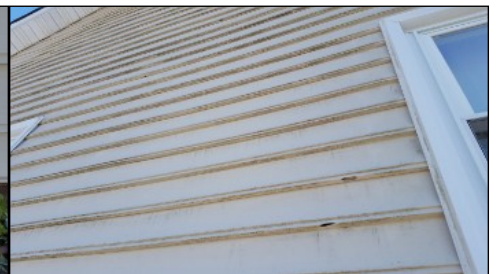
2.1. Some minor siding damage was noted. Have repaired as necessary to prevent further deterioration.

holes on the rear of the home

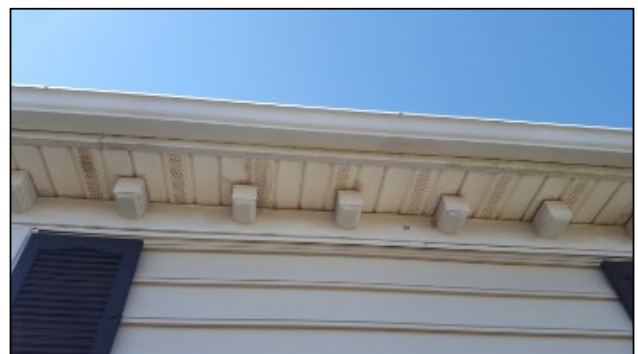
3.2. A piece of the fascia board on the left side of the home was missing. This piece will need to be replaced.

fascia board missing

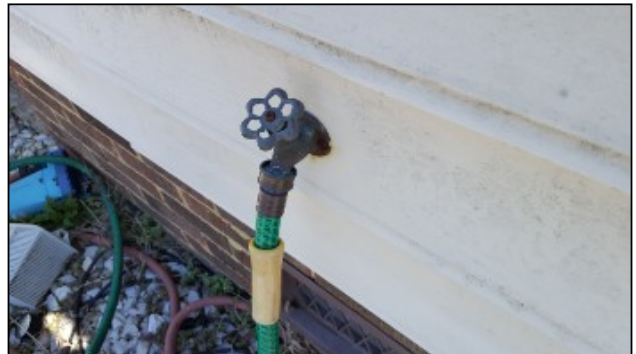
7.1. There were no anti-syphon valves on the hose bibs. Anti-syphon valves are used as a vacuum breaker to prevent cross contamination.

No anti siphon

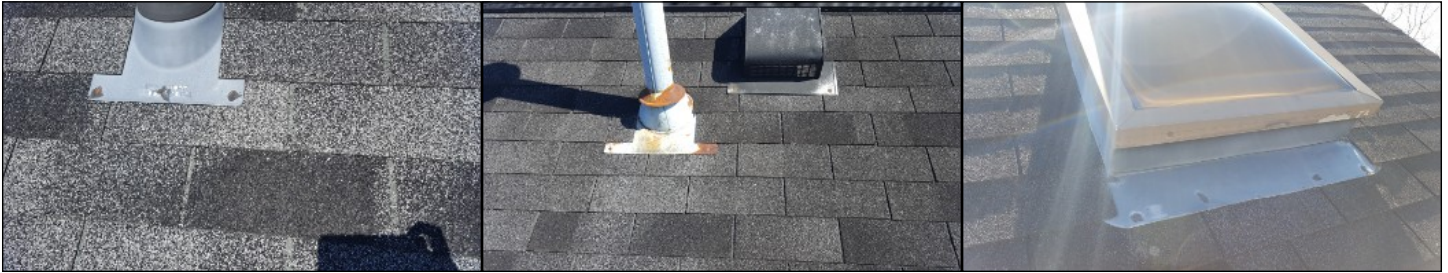
2.1. All exposed nails need to be caulked to prevent any water intrusion.

caulk all exposed nails

exposed nails

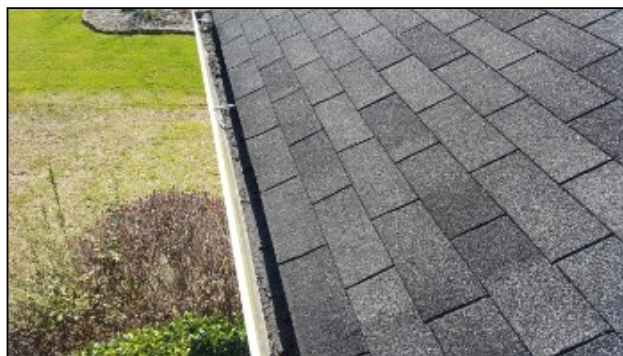
6.1. The gutters need to be cleaned. Debris build up in the gutters will not allow them to drain as they were intended to.

clean gutters

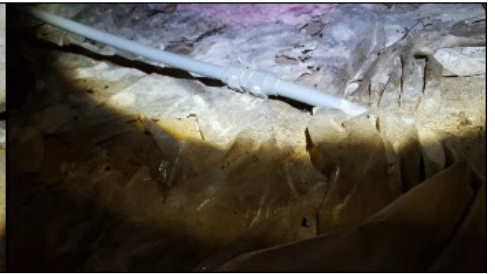
2.4. The water supply piping appears to be PB pipe. PB pipe is not used anymore due to issues with the integrity of some of the piping. More information can be found here <http://www.polybutylene.com/poly.html>

pb as service entrance

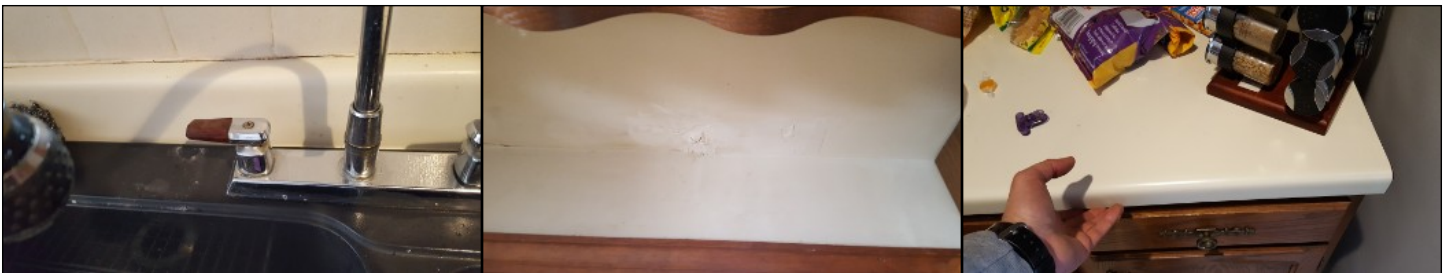
hot water side stripped

light removed

counter top is loose

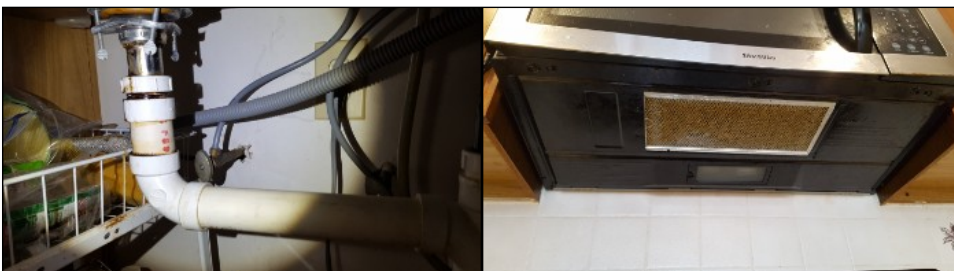
2.1. The dishwasher does not have a high loop installed. An example of a high loop has been included.

2.2. The grease trap on the microwave should be cleaned.

No high loop

clean grease trap

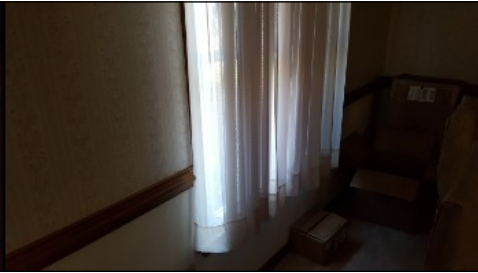
2.1. The window in the dinning room would not stay up on it's own. This could be a concern with emergency egress.

window won't stay up

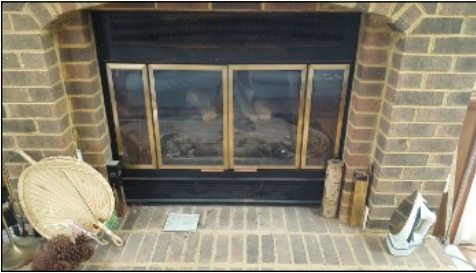
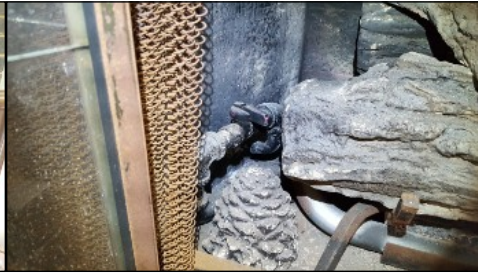
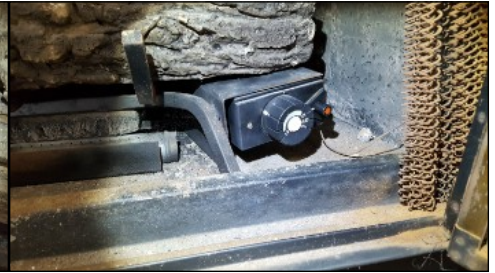
4.1. Have a professional chimney sweep evaluate the gas fireplace prior to closing. The gas line was off to the unit and it may be due to some concerns with the unit. Please note that the damper does not have a clamp to keep it partially open. This is done to prevent the damper from remaining closed and CO to back up into the home.

gas valve is shut off

ignitor

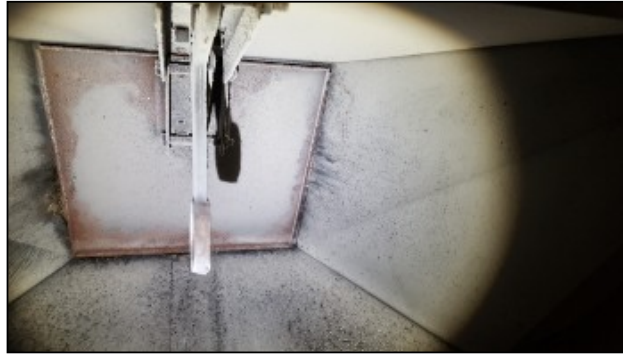
No clamp installed

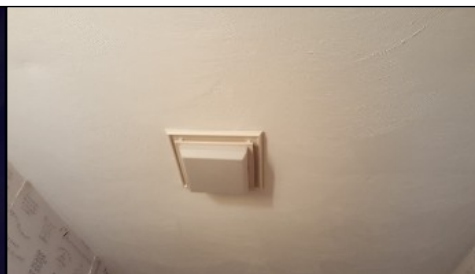
2.2. The vent fan in the hall bath was noisy and may be an indication of failure in the near future.

fan is noisy

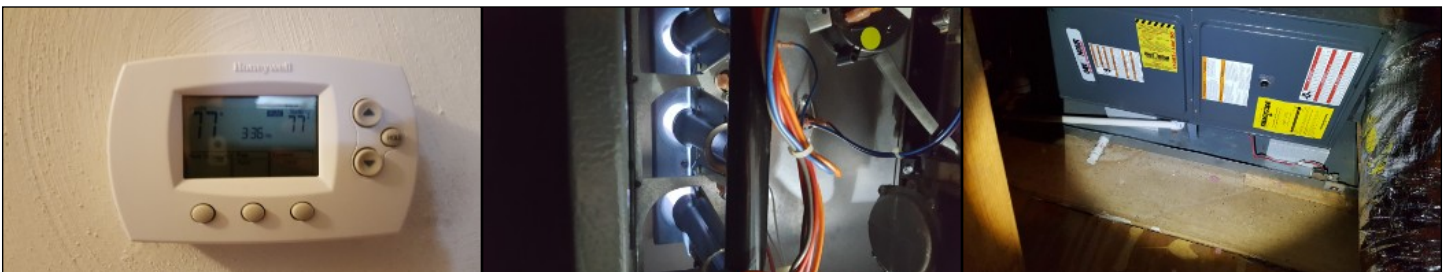
dirty filters

system may need a cleaning

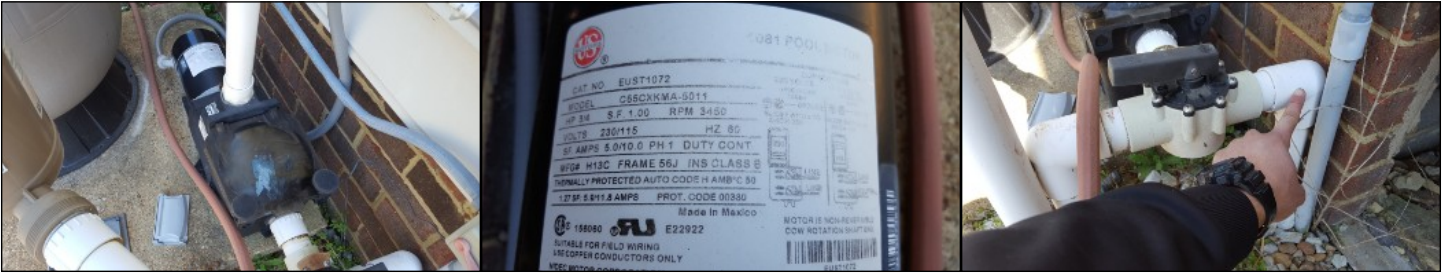
turns of skimmer

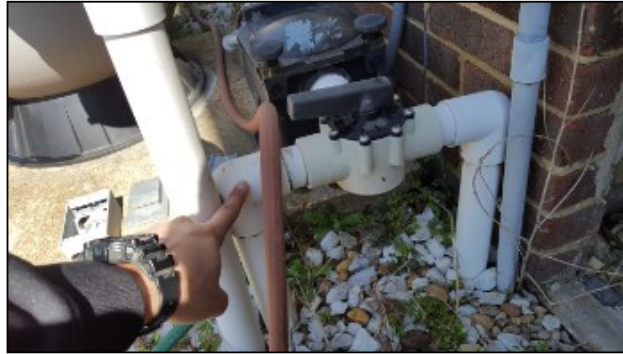
turns off bottom drain
